# INDOOR AIR QUALITY ASSESSMENT

Westminster Town Hall  
3 Bacon Street  
Westminster, Massachusetts

Prepared by:  
Massachusetts Department of Public Health  
Center for Environmental Health  
Emergency Response/Indoor Air Quality Program  
November 2005

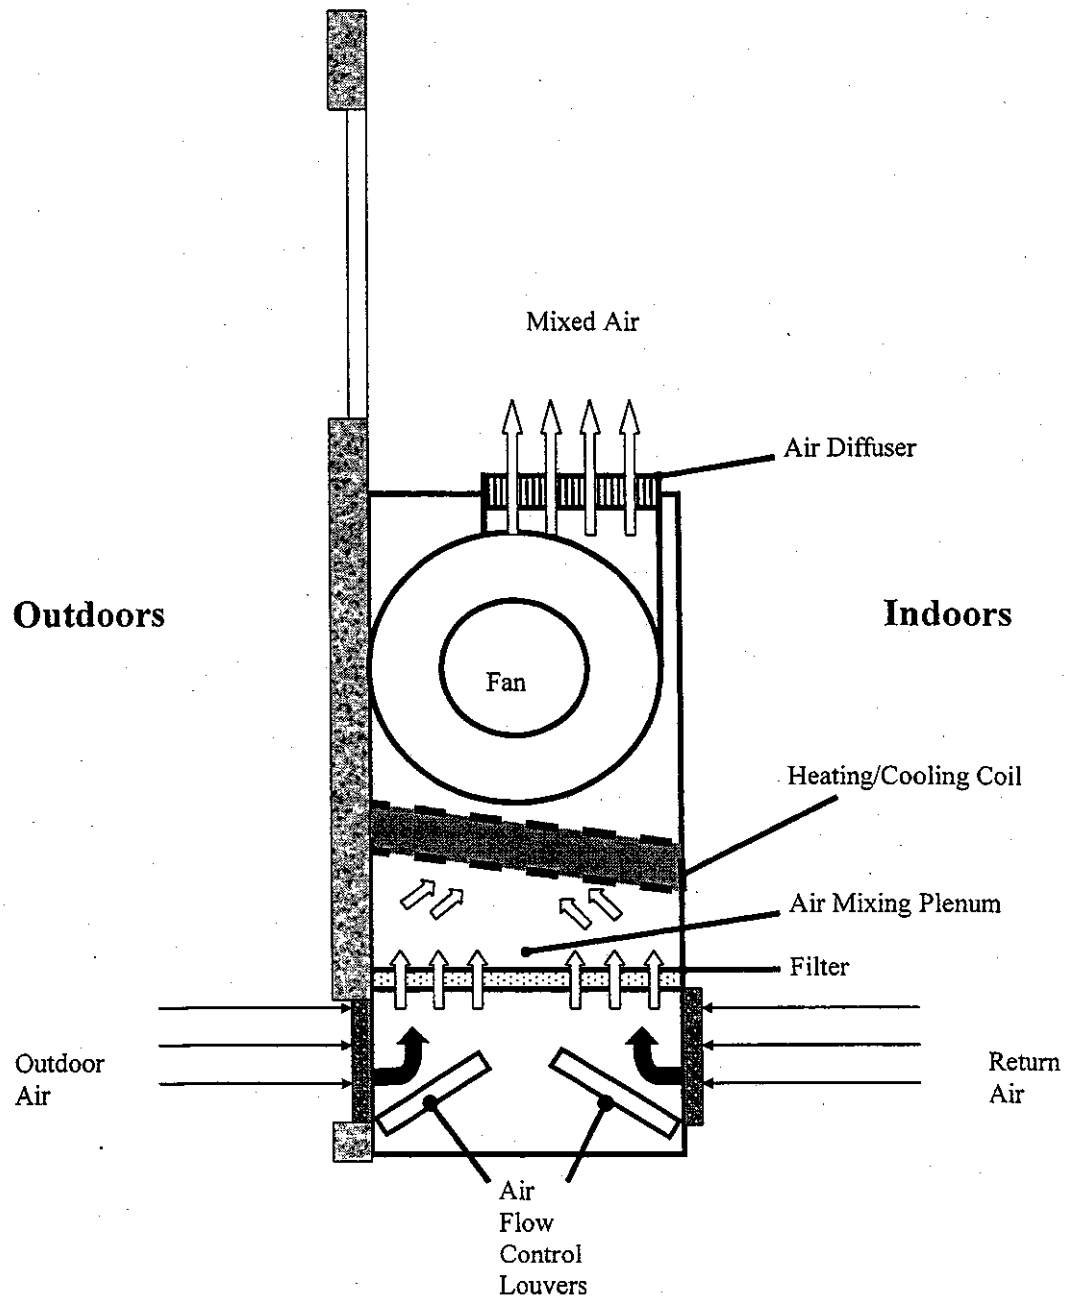
**Figure 2**

Fresh air ventilation is delivered by unit ventilators (univents) that were retrofitted into the building. A univent draws fresh air from a vent on the exterior of the building and air from the room (called return air) through a vent in the base of its case (Figure 2). Fresh air and return air are mixed, filtered, heated and provided to rooms through an air diffuser located in the top of the unit. The univents were deactivated during the assessment. The town hall originally had a large room on the first floor serviced by a single univent. The auditorium was also originally a large open room, provided with heat by two univents. Both floors were subdivided into offices without apparent consideration of the location of ventilation systems. Offices were created by construction of interior walls using paneling or GW. In one instance an interior wall was constructed over the univent casing on the first floor (Picture 9). Routine filter changing and maintenance cannot be done on this univent without dismantling the interior wall. Hence, the first floor has two rooms with one univent that was covered by an interior wall. All other rooms on the first floor have no mechanical ventilation. The second floor had some of the auditorium divided into offices which have no mechanical ventilation. The auditorium has two univents that were deactivated during this assessment.

**Unit Ventilator (Univent)**

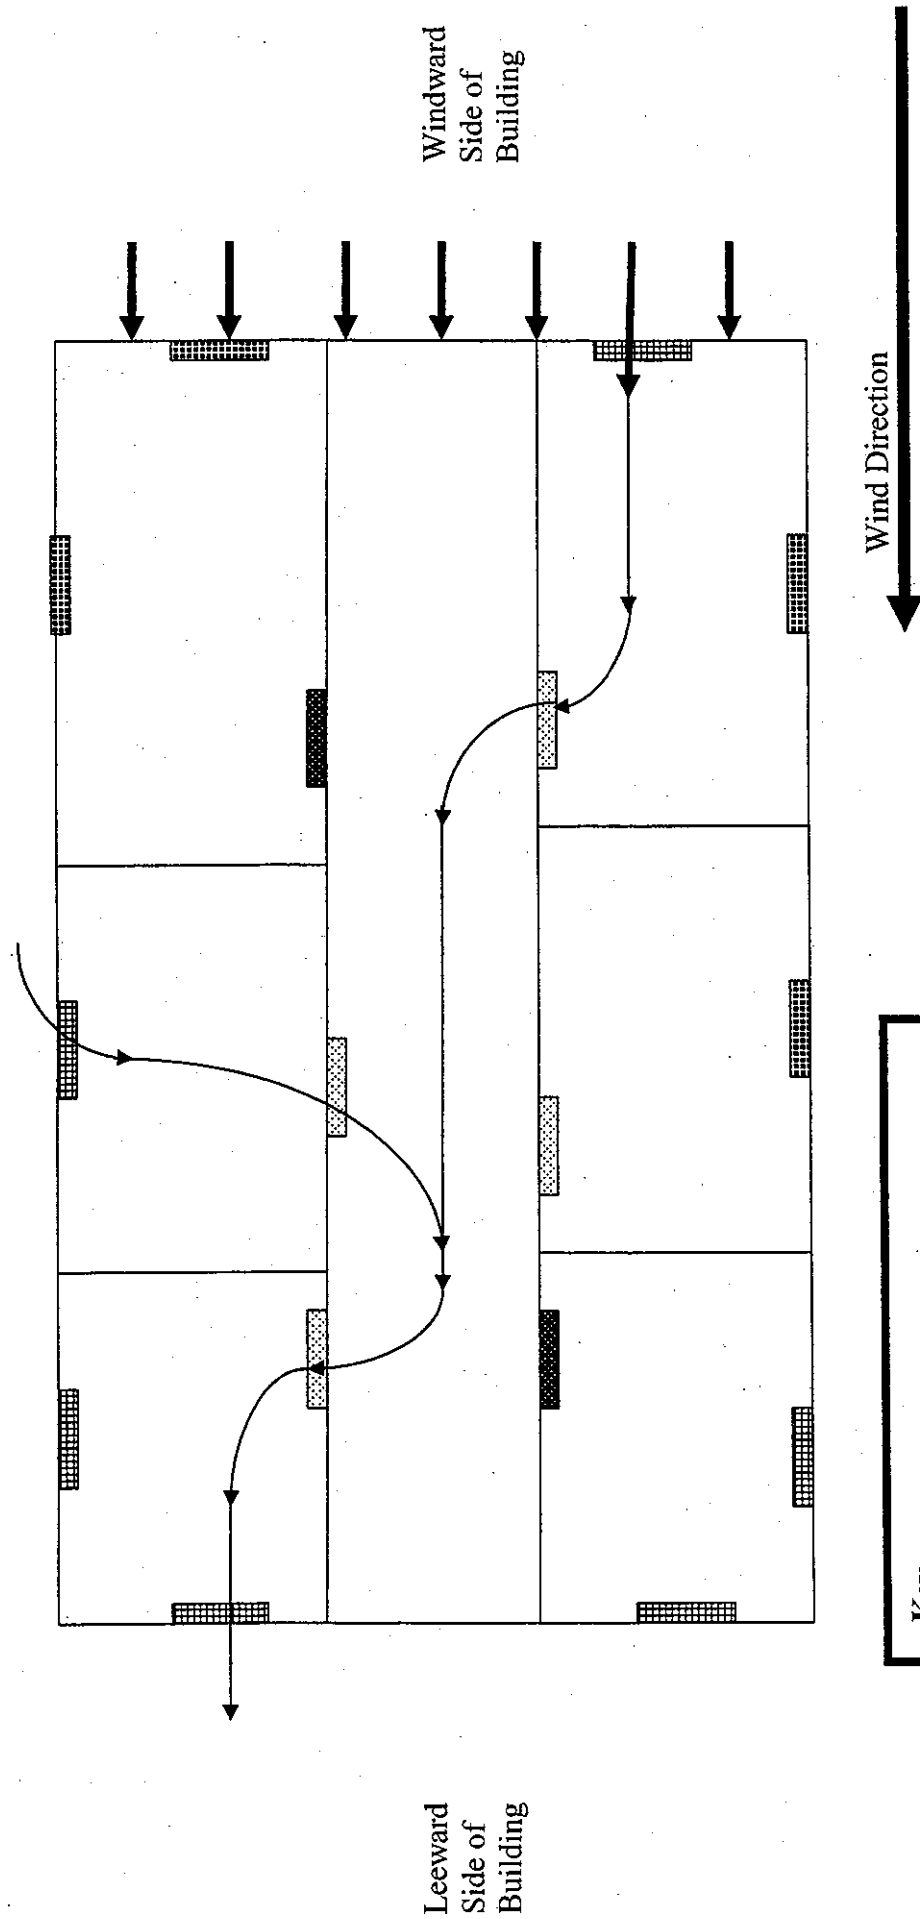
**Figure 4** Inhibition of Cross Ventilation in a Building with Several Windows and Transoms Closed

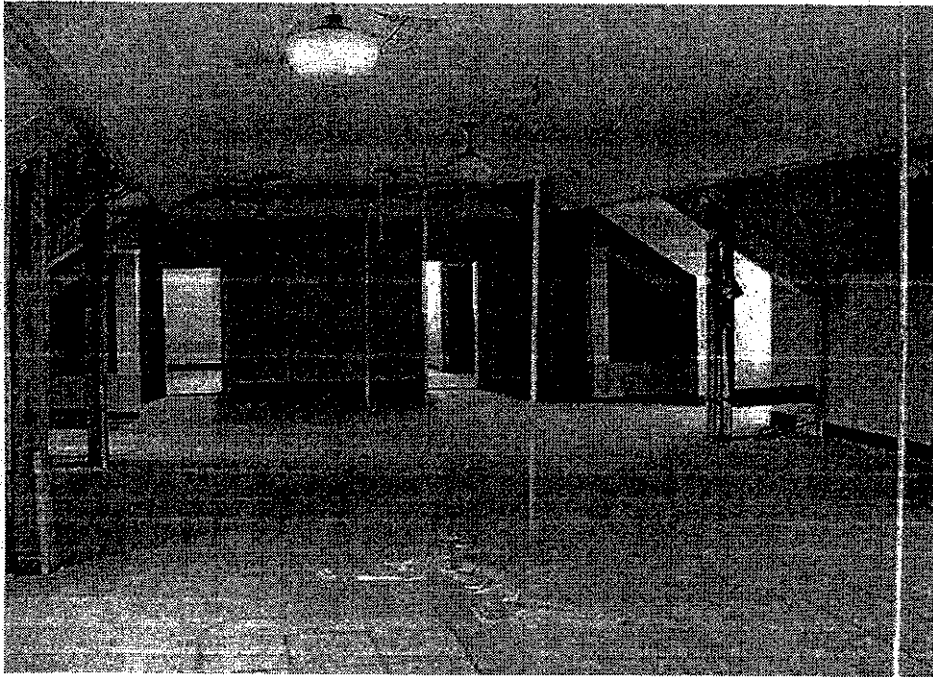
**Picture 1**

The town hall had undergone major structural refitting to preserve the structural soundness of the building. Substantial stabilization and repairs to portions of the roof and uppermost level were done in 2000. The topmost level contains a series of iron tie rods (Pictures 1 and 1A) that connect the floor/auditorium ceiling to the ridge beam of the roof. This design would transfer the weight of the floor/auditorium ceiling and materials on the floor (called load), which would pull downward on the roof peak. This load would then be transferred to the roof rafters, which would then push outward on the exterior wall of the building. In order to provide roof support, horizontal beams connected to the rafters were inserted into a vertical wooden beam (called and mortise and tenon joint)

**Tie Rods Connecting Auditorium Ceiling to the Roof**

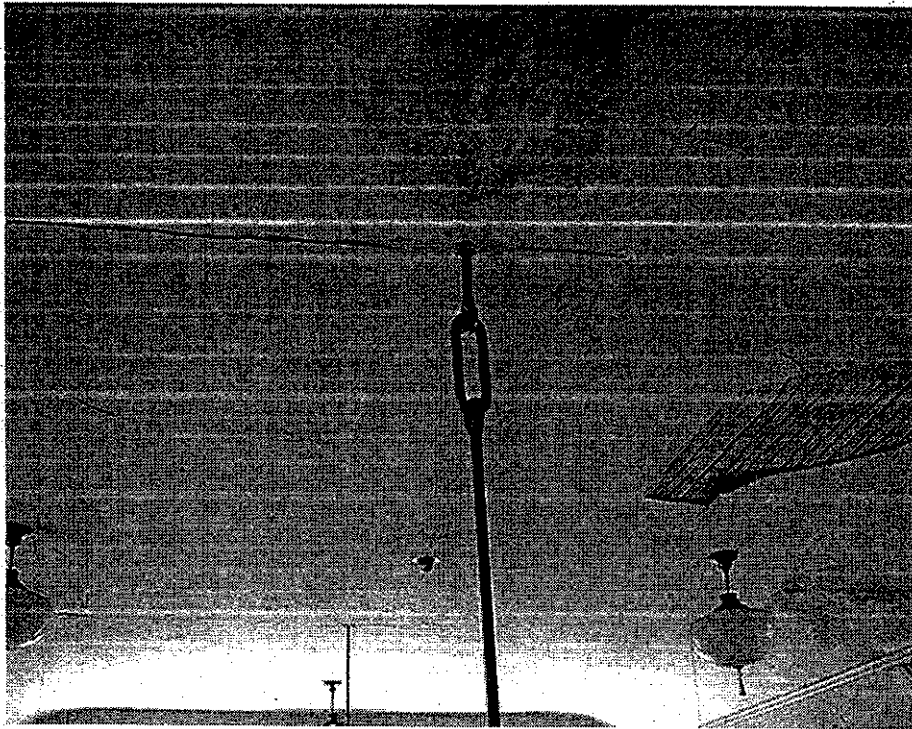
**Picture 1A**

**Close-Up of Tie Rod in Picture 1**
